**Acton-Shapleigh**  
**Youth Conservation Corps**  
**Season in Review**  
Annual Season Program Report  
2009

# The Acton-Shapleigh Youth Conservation Corps

## Executive Summary

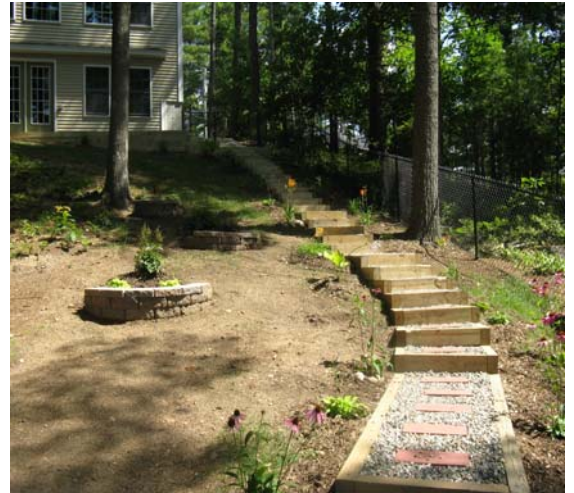
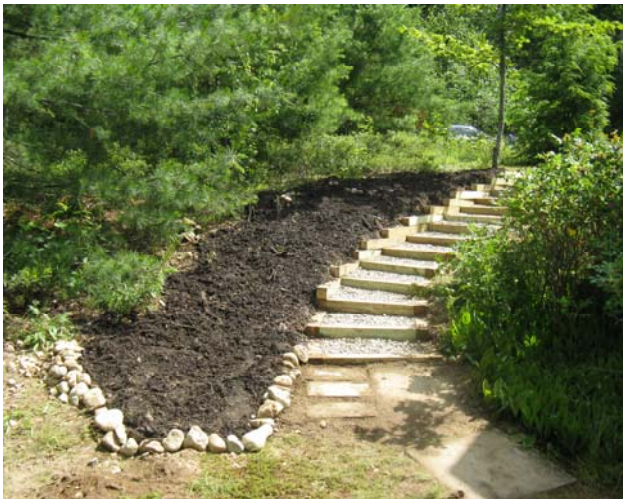
- Break down of projects by lake
  - Mousam Lake, Shapleigh: 8
  - Mousam Lake, Acton: 2
  - Square Pond, Shapleigh: 6
  - Square Pond, Acton: 0
- Number of technical visits: 29
- Number of technical reports: 21

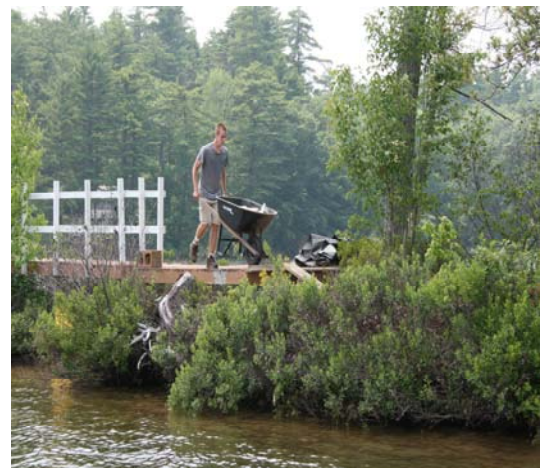
### Conservation Practices Installed:

- Rubber Razor Blade
- Infiltration Trench

- Drip Line Trench
- Water bar
- Infiltration Pathway
- Shoreline vegetation
- Slope Stabilization  
Planting
- Vegetated Buffer Strip
- Rip Rap
- Retaining Wall
- Drywell
- Mulching
- Other
