The Acton-Shapleigh Youth Conservation Corps

2011 Season Report

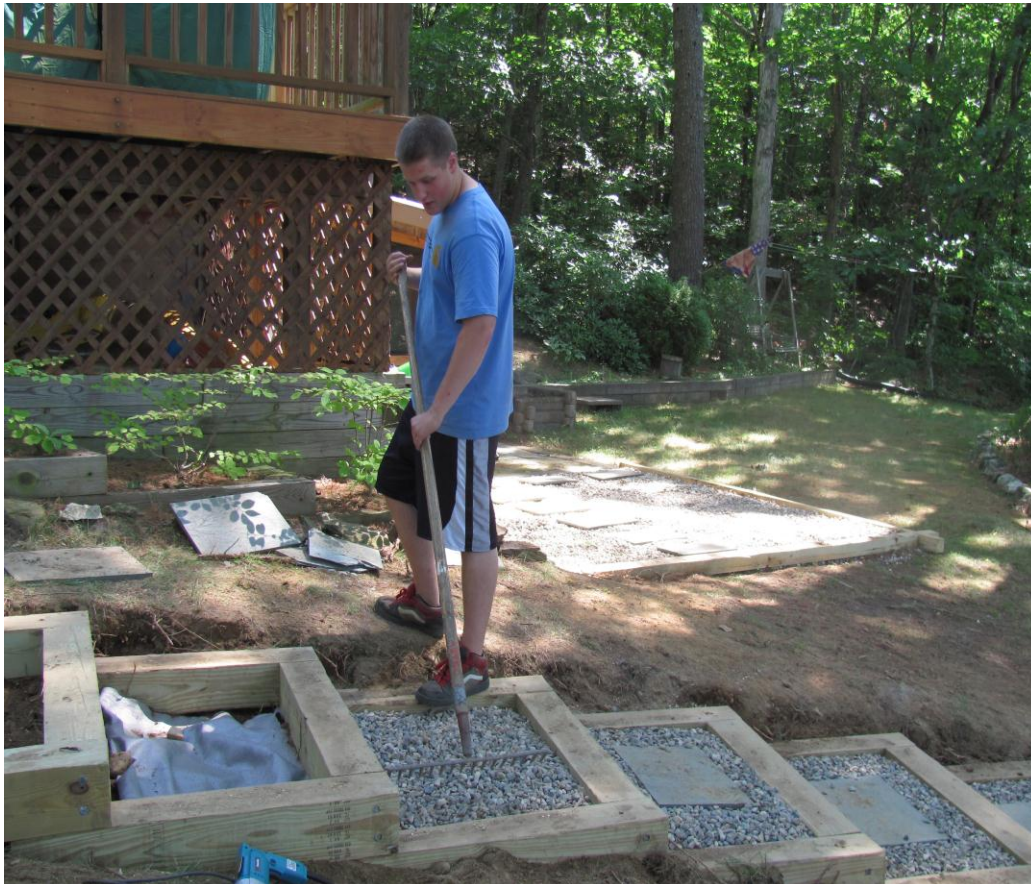
2 -An ECC member working on infiltration steps

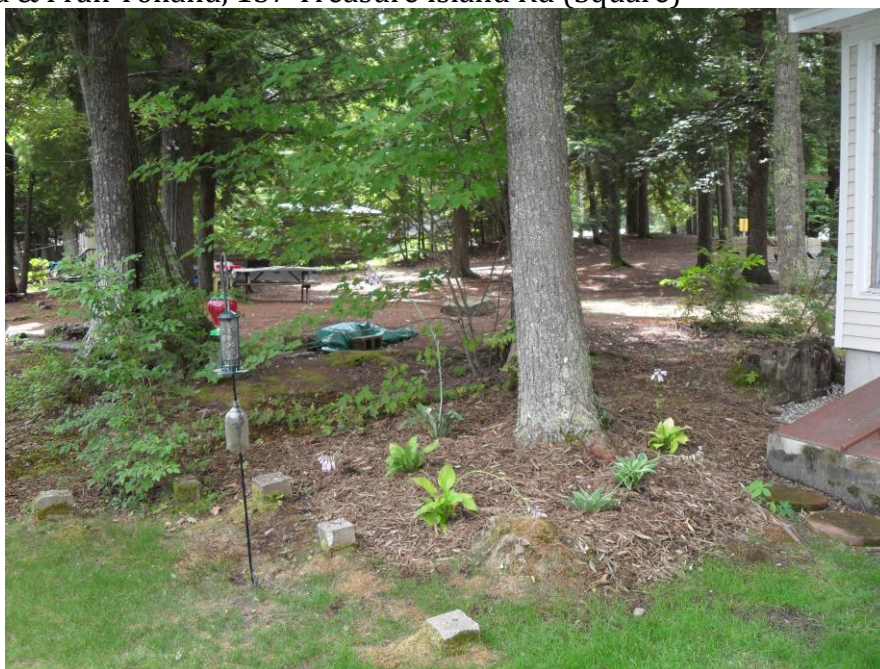
2- A drip line trench emptying into a rain garden that is constructed around an existing tree.

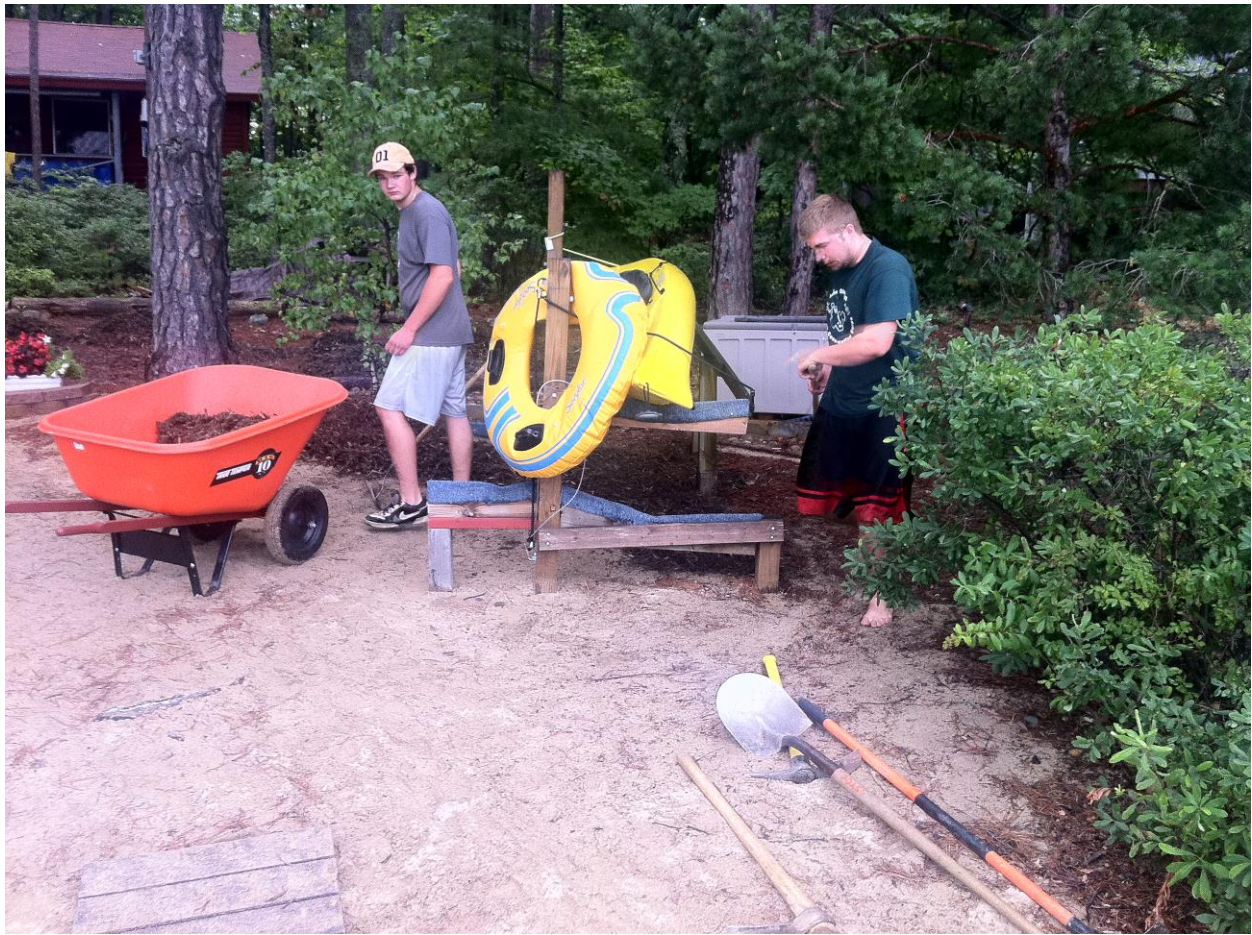
3- ECC members stabilizing soil with Soil Conservation Mulch
