The Acton-Shapleigh Youth Conservation Corps

2012 Season Report

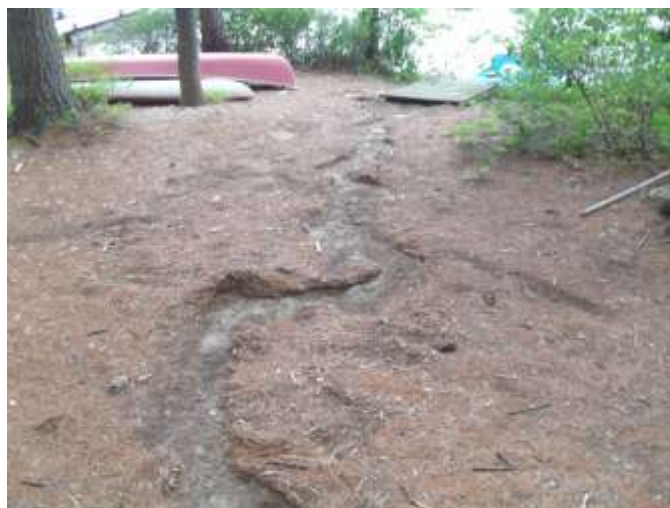
Figure 2 One of the many examples of erosion caused by residential development. Photo taken at Mousam Lake on one of the properties we implemented Best Management Practices.

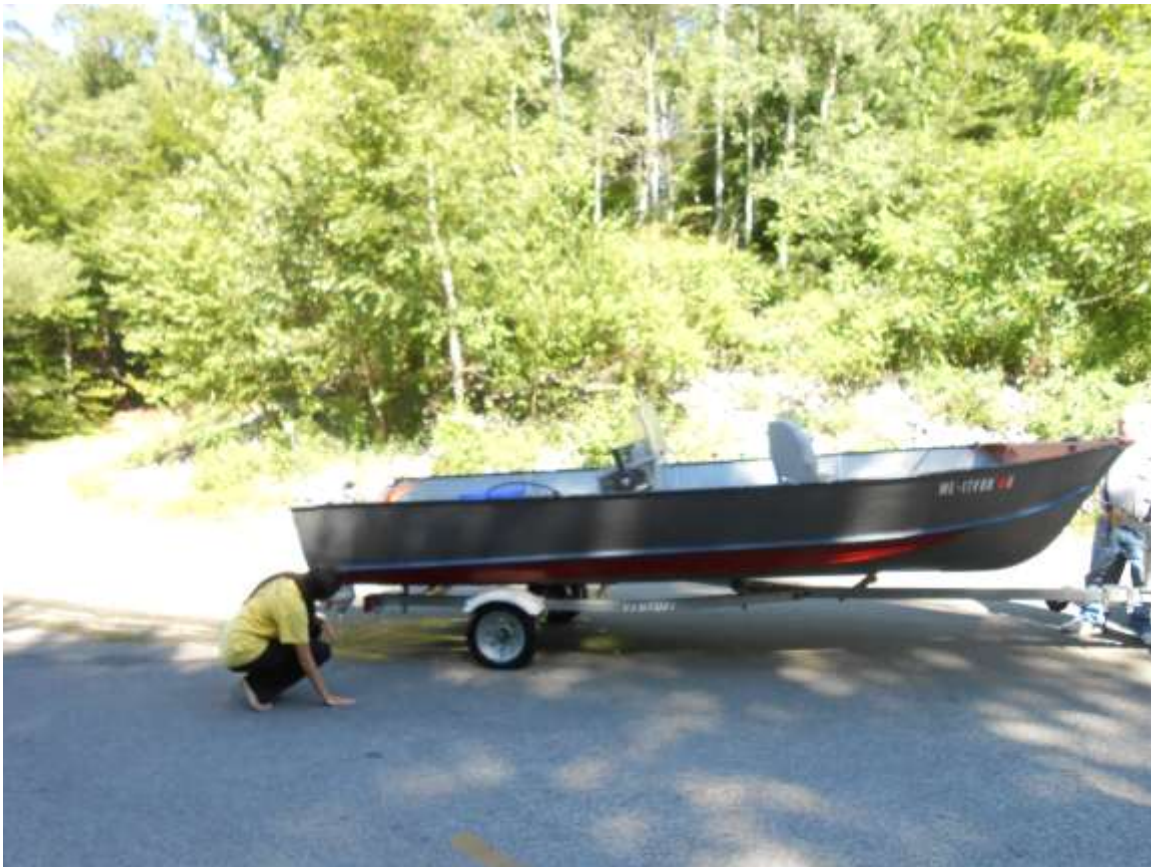
Figure 4 ASYCC Courtesy Boat Inspector thoroughly looking over a boat before entering Mousam Lake.

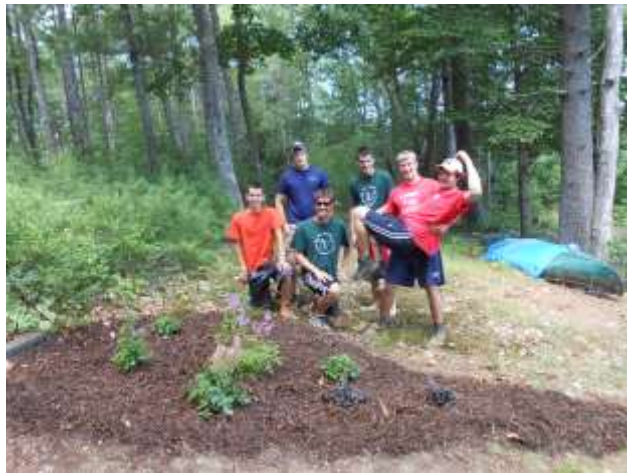
Figure 5 The Erosion Control Crew showing off their Loon shaped Rain Garden.

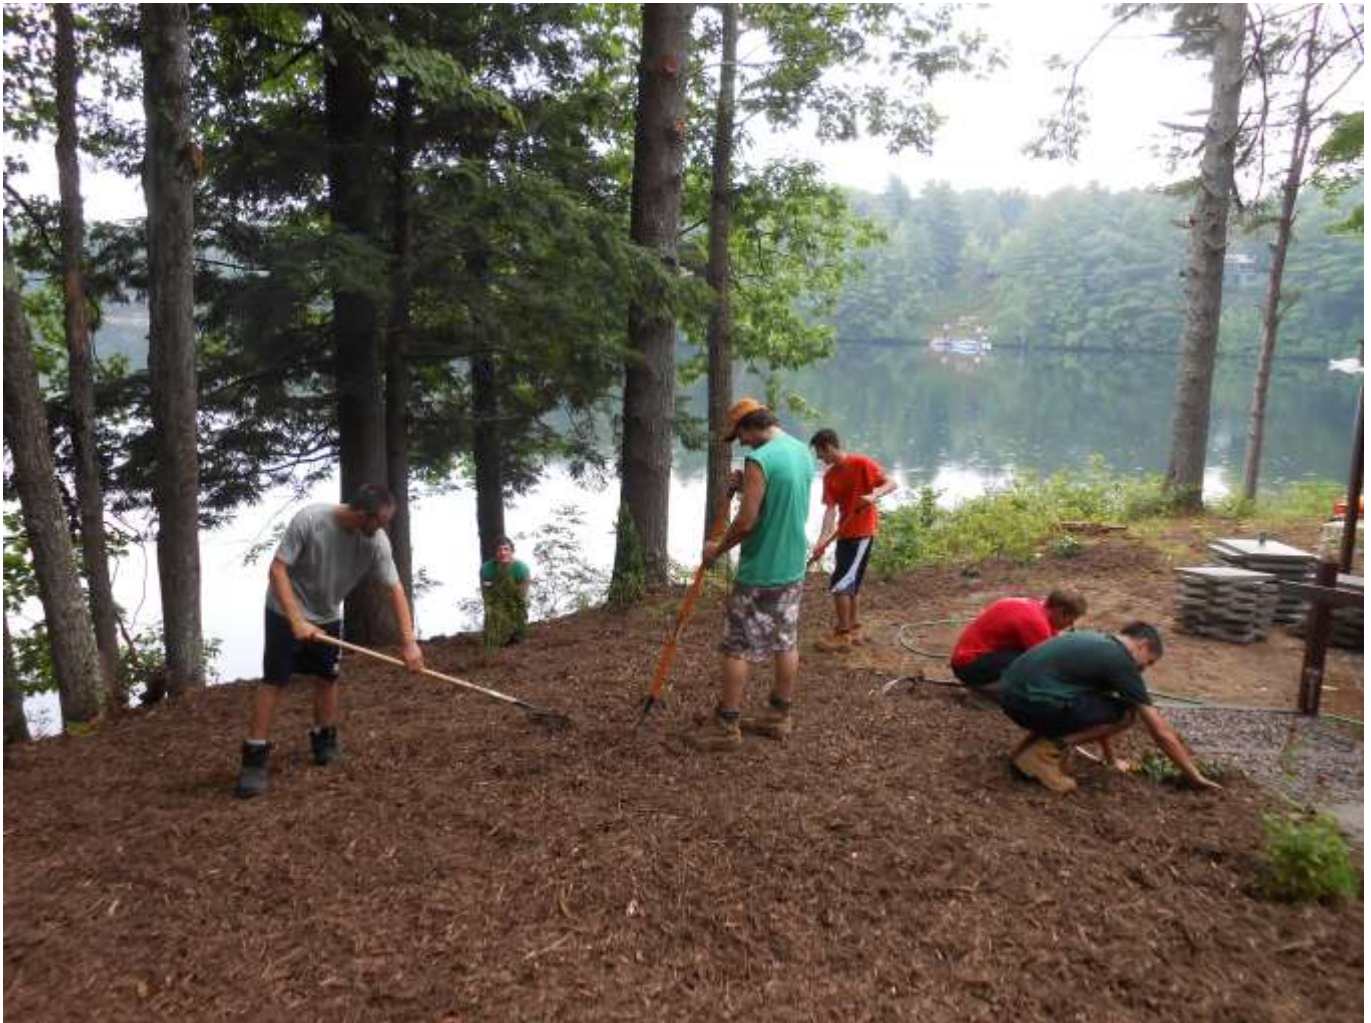
Figure 8 The ECCs spreading mulch and planting native Maine bushes.

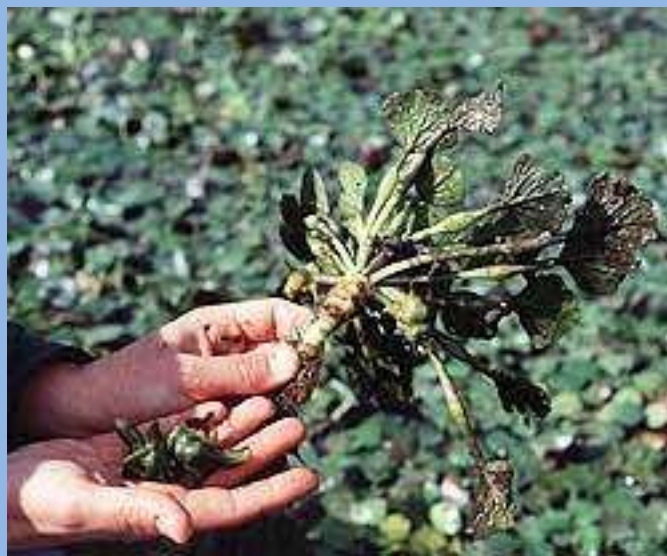
Photo from google images. Water chestnut, an invasive aquatic plant, was discovered on a boat trailer last Saturday by a courtesy boat inspector at Mousam Lake.
