Loon Pond Watershed Survey Acton, Maine November, 2011

Prepared by:
York County Soil and Water
Conservation District
11/1/2011

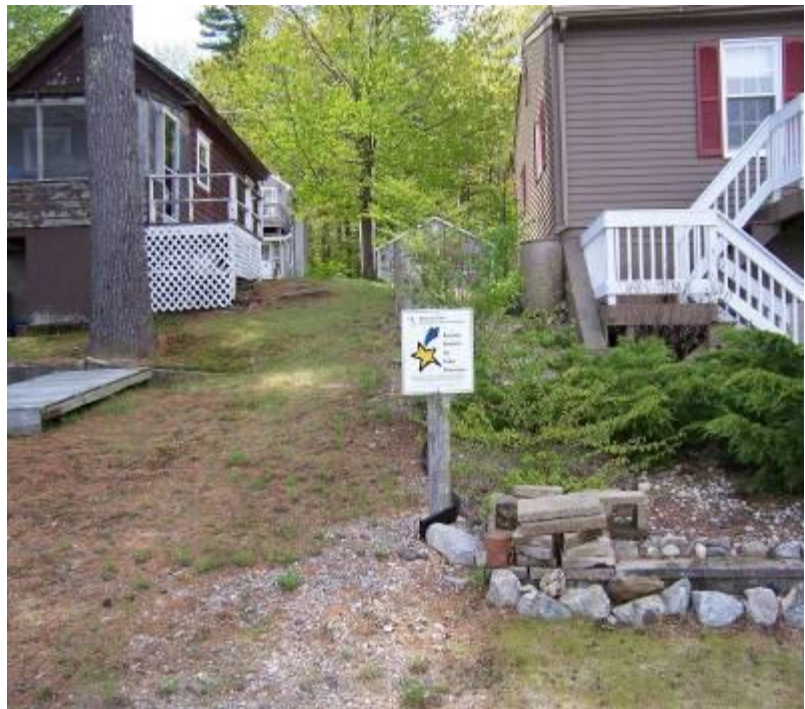
photo J.Anderson, 2011

A great example of how residential properties differ on Loon Pond. Notice the mix of shrubs and ground covers to the house on the right. Next to the stairway, the gutters are connected to a rain barrel which can be used to water their gardens. Recommendations for the house on the left included adding vegetation for a shoreline buffer, installing a stabilized pathway and covering bare soils with erosion control mulch. The Acton-Shapleigh Youth Conservation Corps worked with the landowner on the right to help improve their site (see sign).

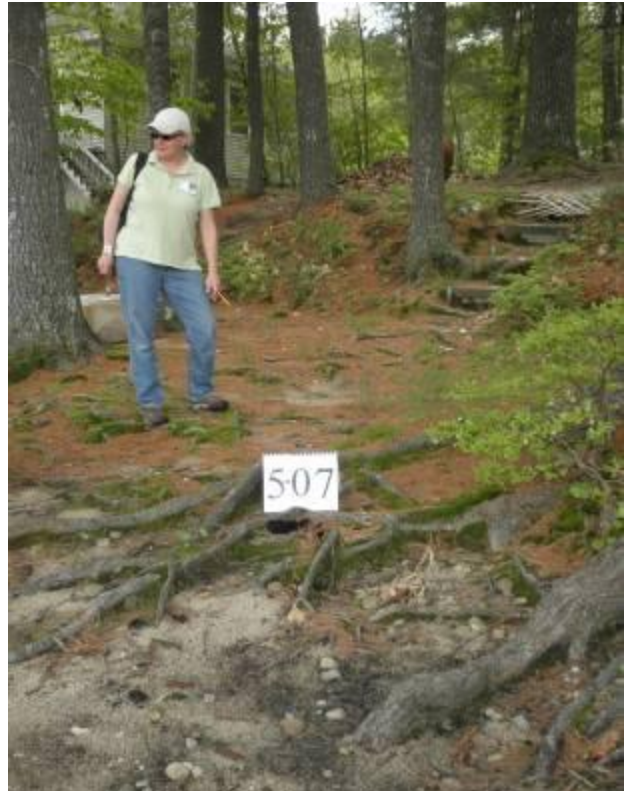
Soils that surround Loon Pond are made up of sand and gravel and erode easily. Bare sites are particularly susceptible to erosion when it rains. Here a pathway can cause significant erosion given the amount of rain collected and the force it generates as it travels down the path. Notice the exposes tree roots which were once covered with soil.

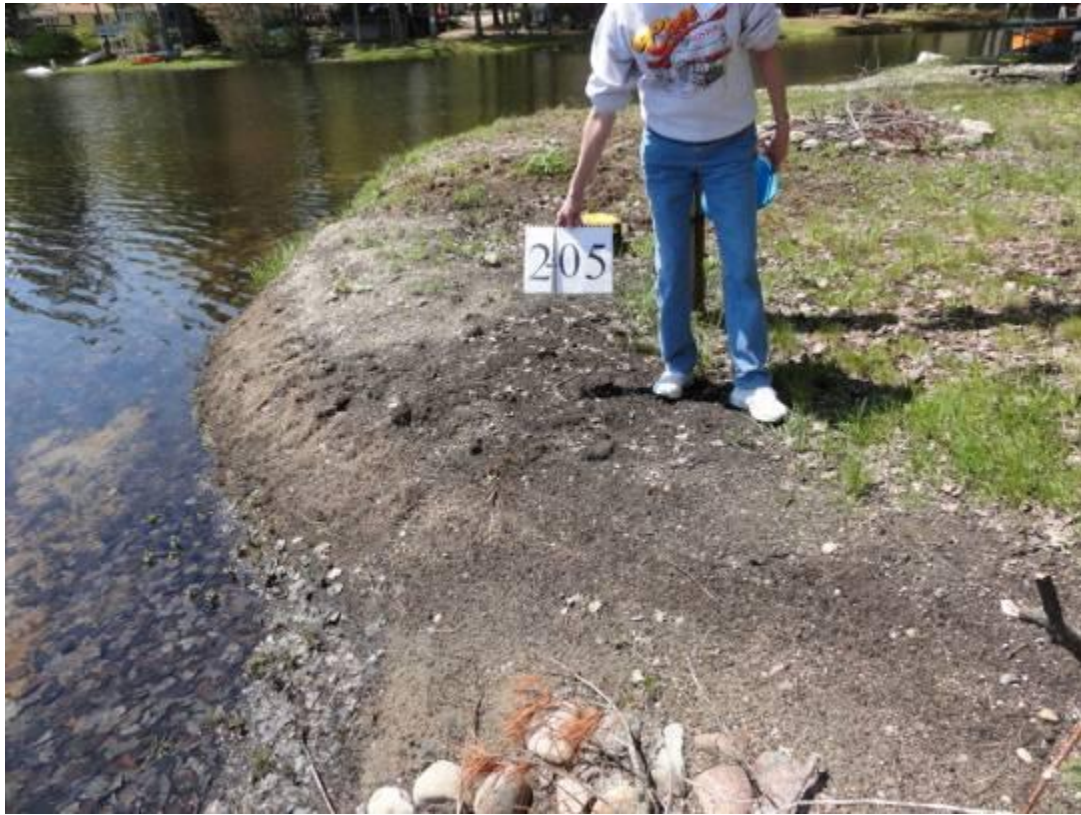
Many sites documented around Loon Pond (over 50%) were connected with inadequate shoreline vegetation. By establishing a buffer of vegetation at the water's edge, not only will stormwater runoff be intercepted from above, the shore will be protected from waves and wind and can offer habitat for birds and fish while still keeping access for boats and swimming.

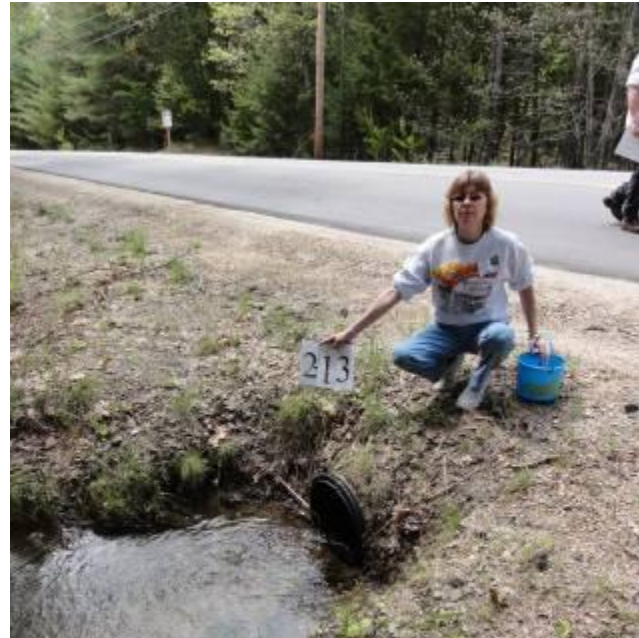
Roads, driveways and culvert crossings can cause significant impacts to water quality. Here the road shoulder and culvert outlet are failing on Milton Mills Road. Sediment can run directly into the stream which reaches Loon Pond less than 200 yards downstream.

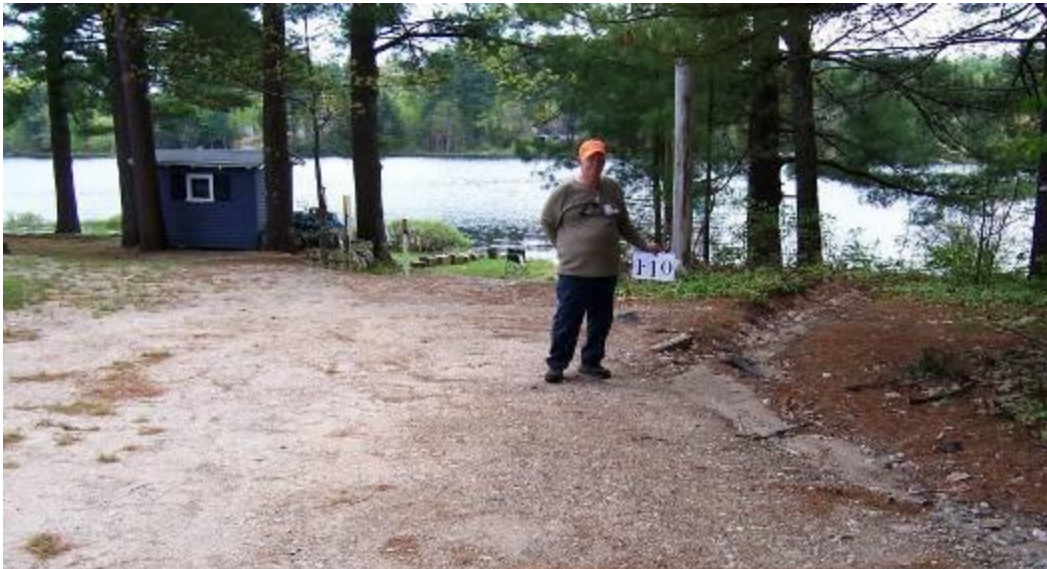
The boat launch located off Loop Road is a high impact due to the amount of stormwater that comes down the road and the bare soil it picks up and deposits directly into Loon Pond. The ASYCC has worked here in past, notice the ditch turnout to the right of surveyor. Sites like these see more concentrated use and constant vehicle traffic which makes it difficult to maintain and expensive for the landowner to keep up.

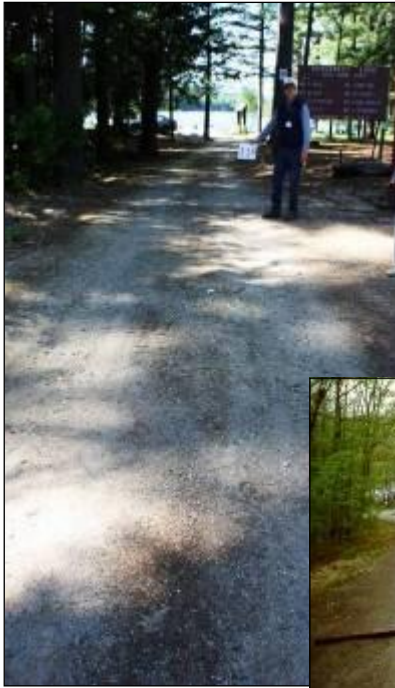
Rubber Razors direct water off the driveway or road and into vegetation with rubber razors.

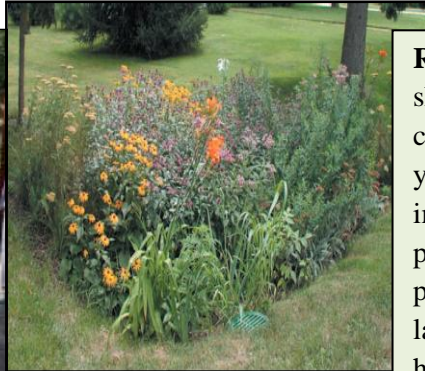
Rain Gardens are natural or dug shallow depressions designed to capture and soak up runoff from your roof, driveway or other impervious areas. They can be planted with beautiful, native plants that add beauty to the landscape while providing habitat and food for birds and butterflies.

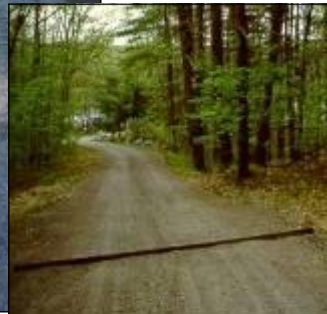
Roof Runoff
Install stone filled trenches along the roof dripline to help catch and infiltrate runoff.

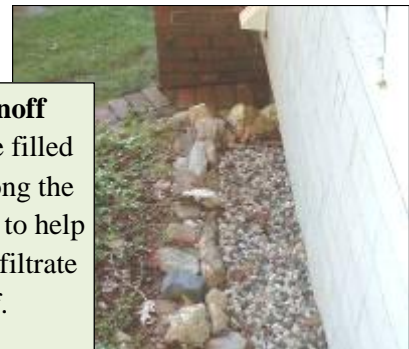
Build a Better Buffer-Soil is the #1 Pollutant of Our Waters

A buffer is an area of land between developed property and the lakeshore where trees, shrubs and ground cover plants are allowed to become established. Buffers help the lake by:
