# Mousam Lake Watershed Survey Report

Mousam Lake Region Association Acton Shapleigh Youth Conservation Corps Maine Department of Environmental Protection Volunteer Lakes Monitoring Program September 2017

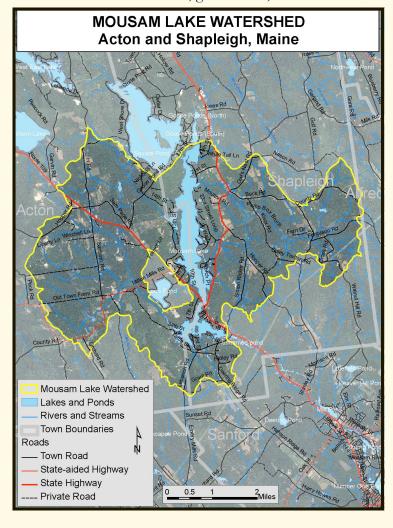
All of the land within the unshaded area (see below) drains directly into the lake through a network of streams, ditches and overland flow. Pump Box Brook, is one major stream that flows into the lake and Goose Pond is also a major source flowing into the lake.

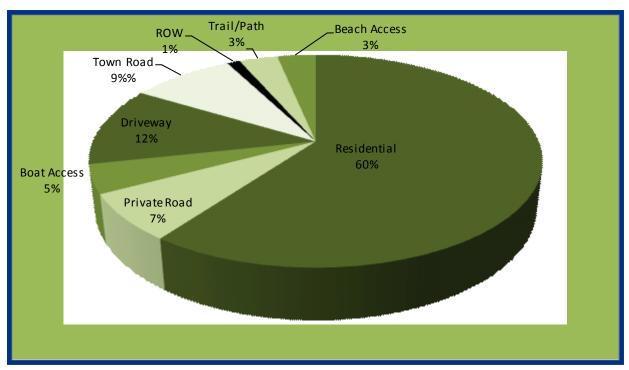
Figure 1. Erosion Sites by Land Use

- Erosion sites were identified all around the watershed and on eleven different types of land uses. Only the top eight land use categories are shown below as the remaining categories have less that 5 sites altogether. As such, everyone has a role to play in lake protection. The Towns of Acton and Shapleigh, shorefront property owners, business owners, road associations, lakefront landowners and even people living far from the lake can all take measures to reduce lake pollution.
